Appendix A

Figures

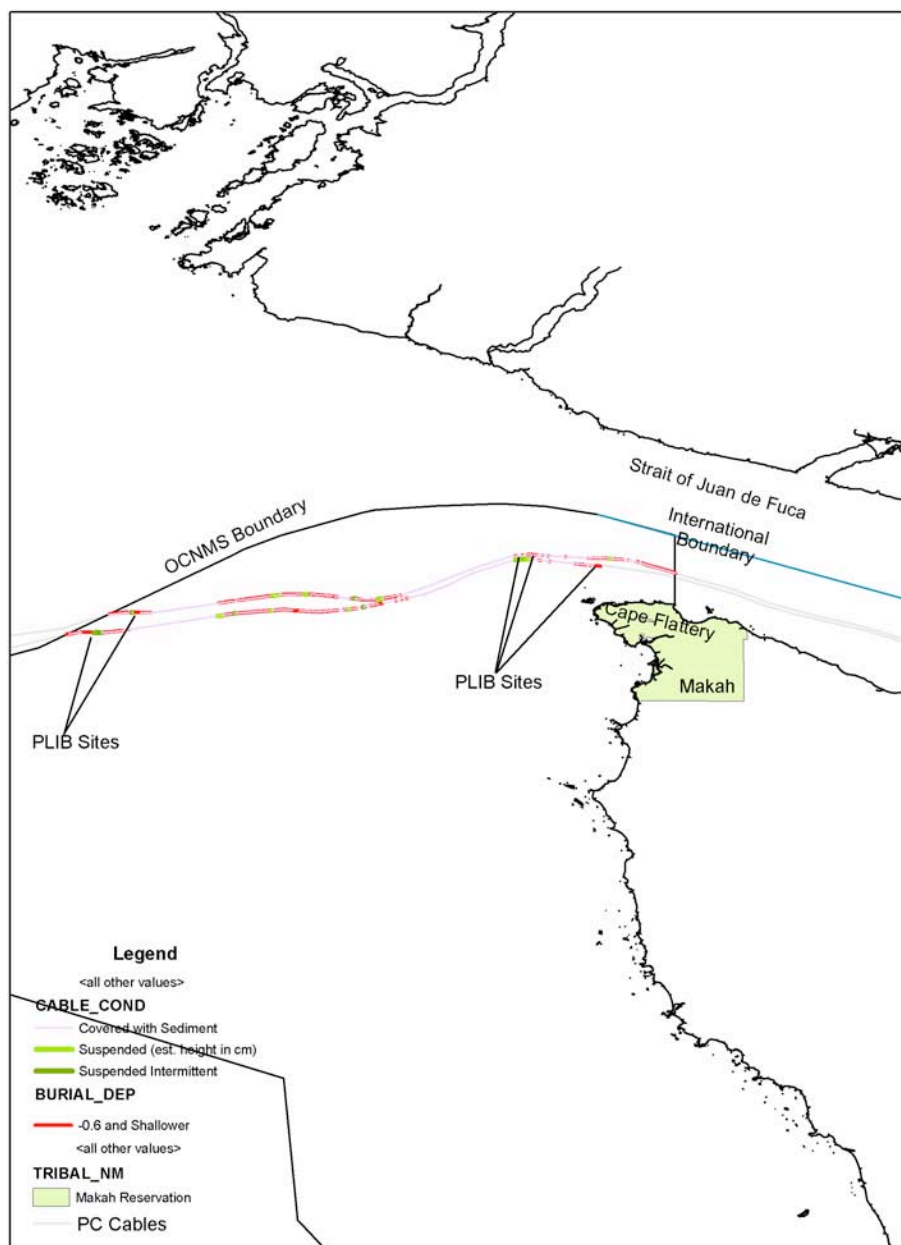
Figure 1 Pacific Crossing-1 Cables in the Olympic Coast National Marine Sanctuary

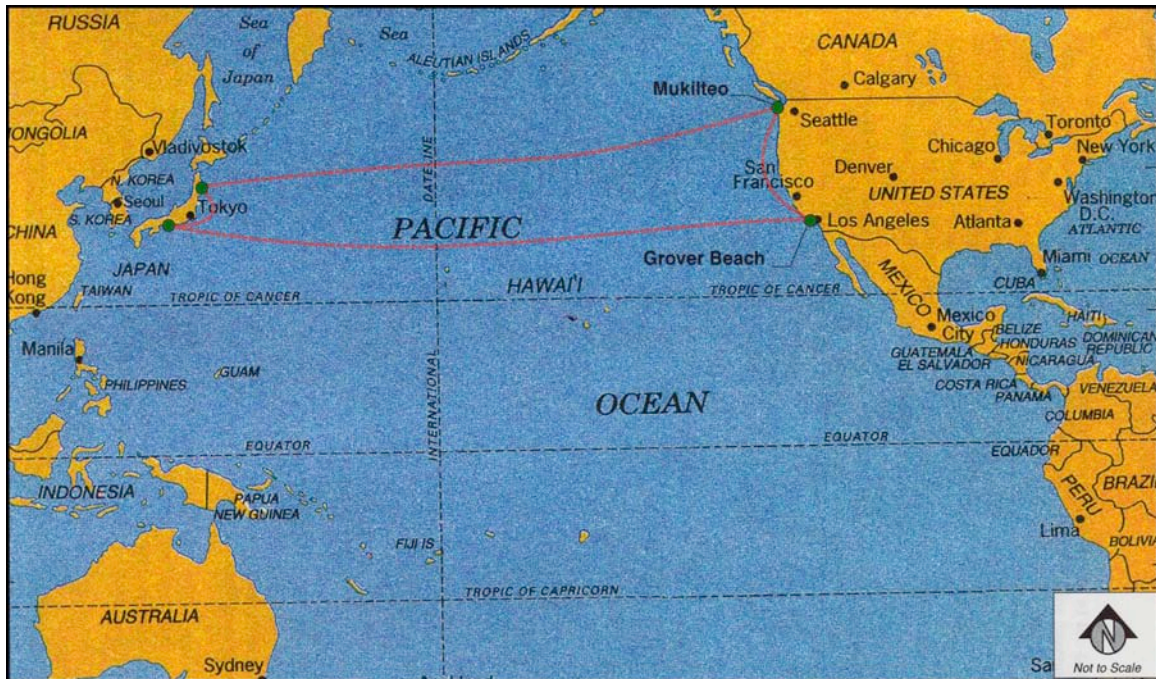
Figure 2 The PC-1 Submarine Fiber Optic Cable System Project Route (from David Evans and Associates 1998)

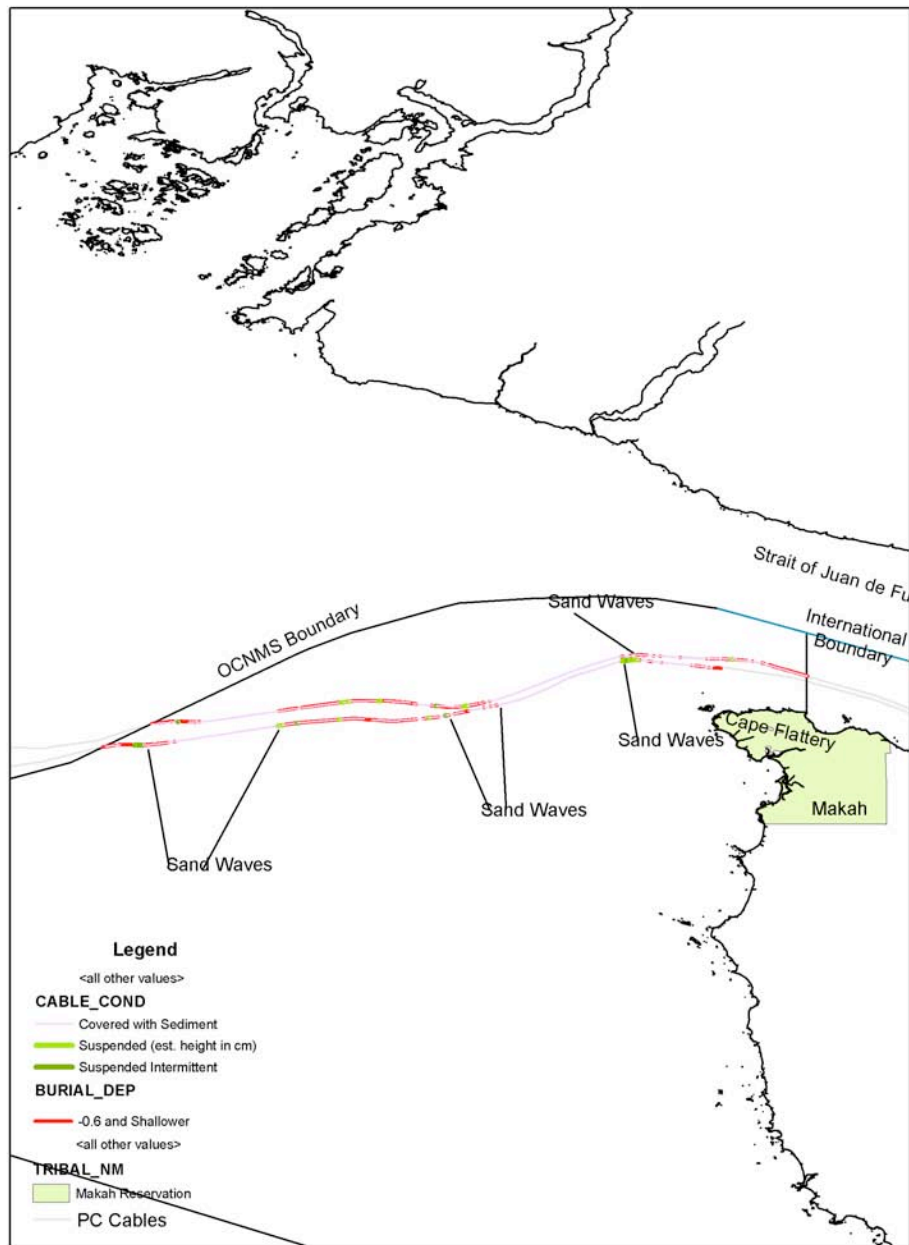
Figure 3 Location of Sand Waves on Pacific Crossing-1 Cable Routes in the Olympic Coast National Marine Sanctuary

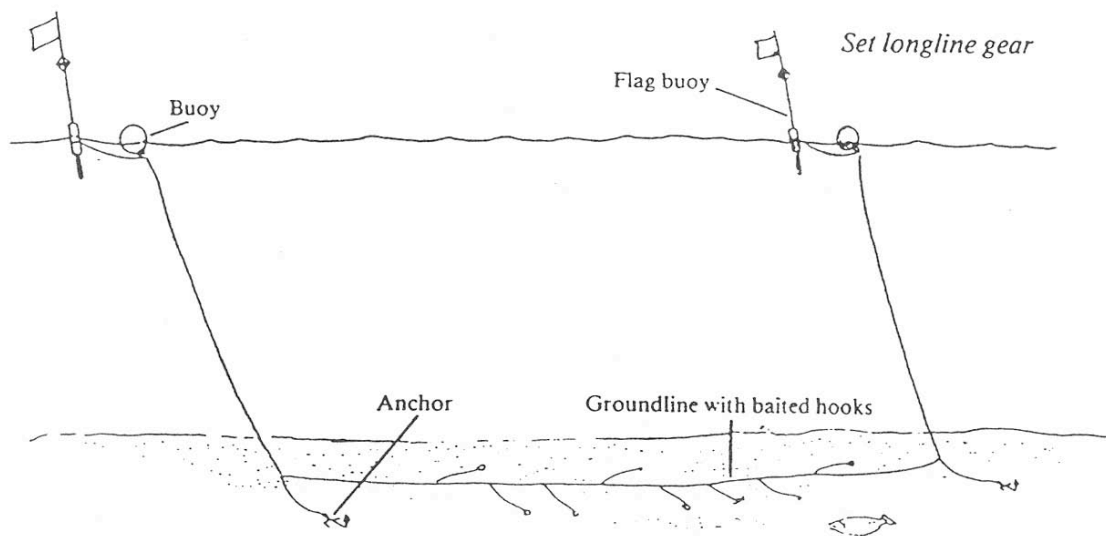
Figure 4 Typical Longline Fishing Gear

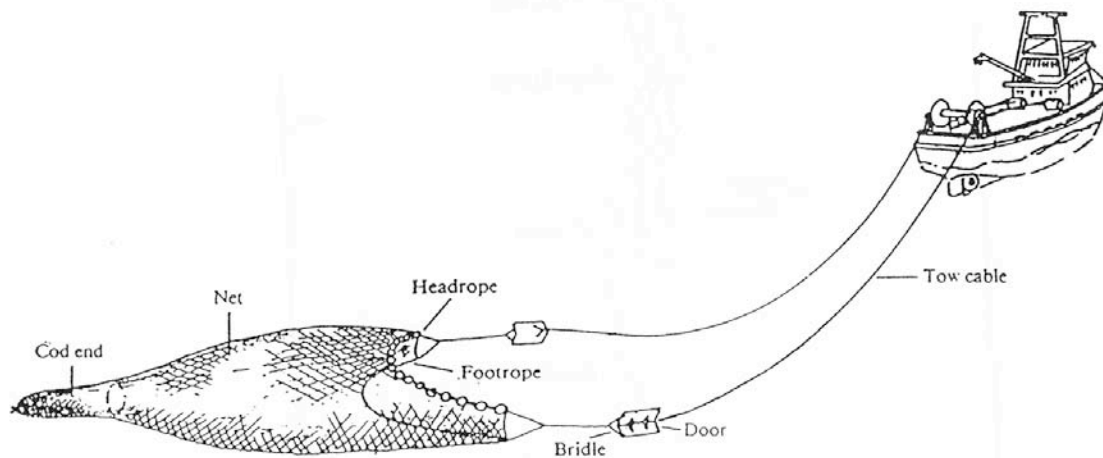
Figure 6 Bottom Trawler with Net Deployed

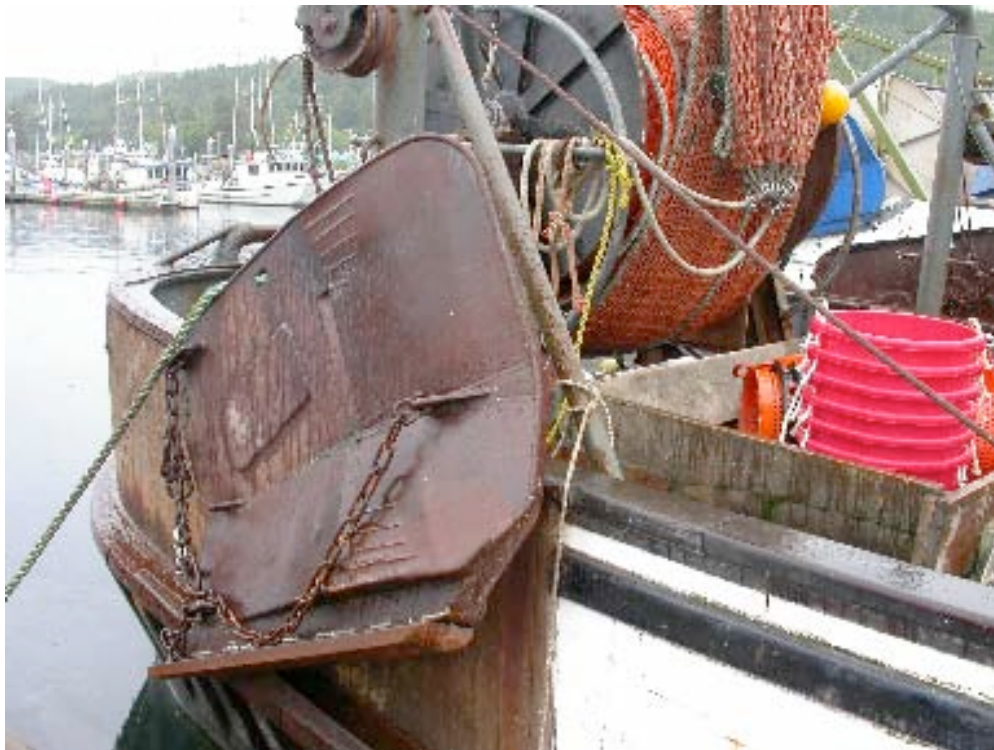
Figure 7 Typical Bottom Trawl Door

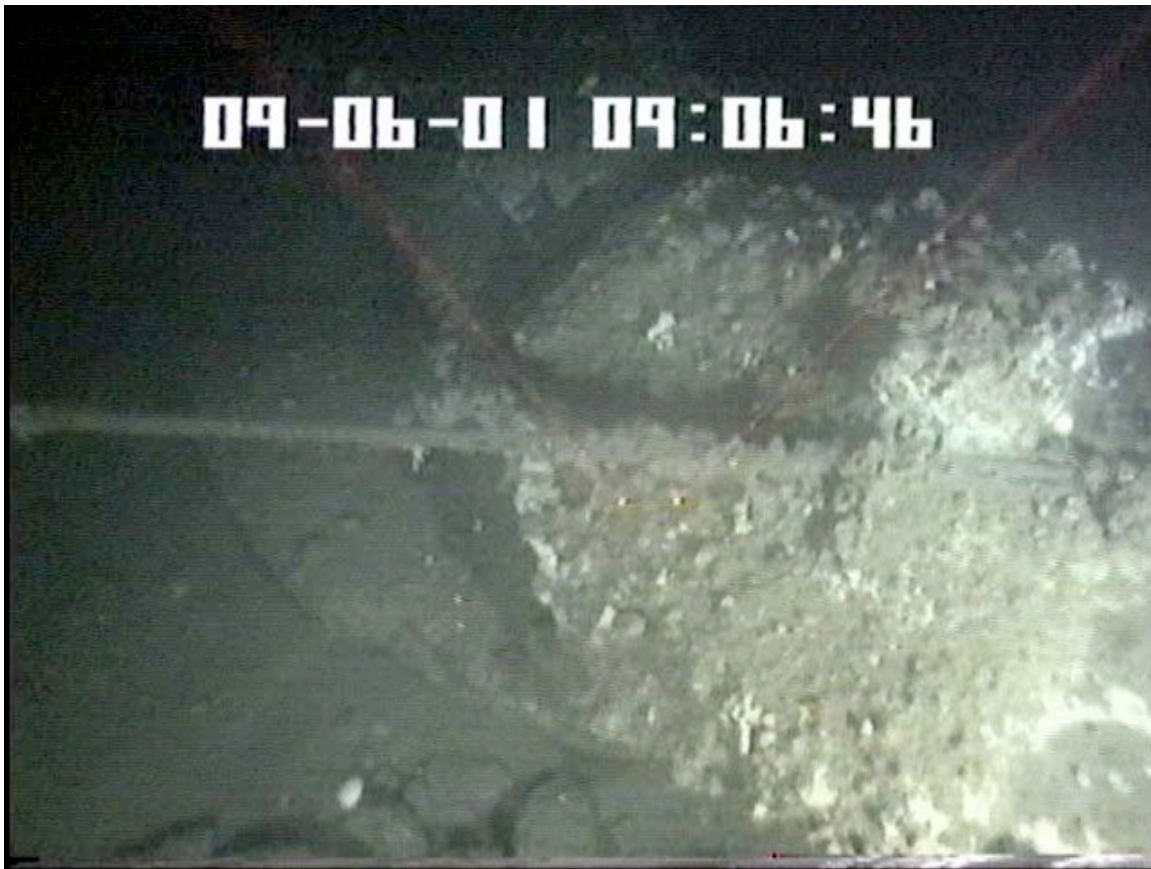
Figure 12 The PC-1 Fiber Optic Cable with Visible Serving Damage Atop a Boulder in the OCNMS

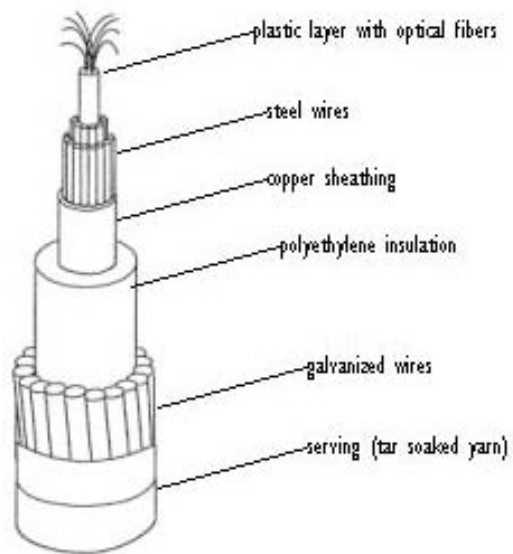
Figure 13 Light Wire Armored Cable
